# Abandoned Uranium Mine Site Assessment for the Blackhawk, Bunney, Red Bluff Nos. 7, 8, 10, & UDC No. 1 Site (NM0074)

FINAL REPORT

NM0074

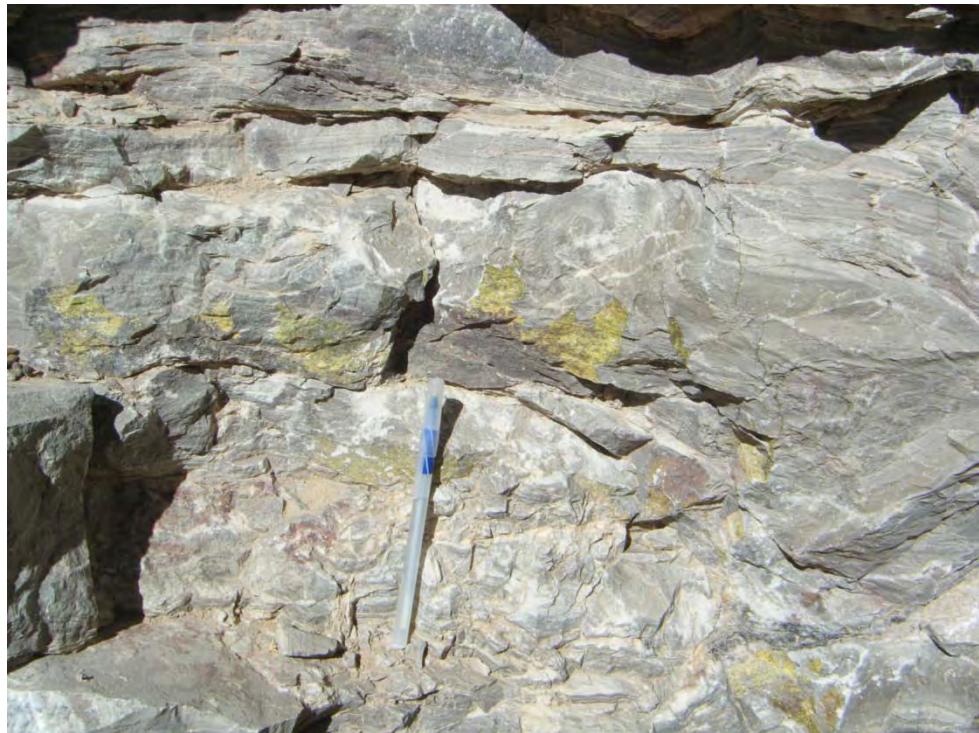
Photo 8-Yellow mineralization at radiation survey point Rad-5 (1800  $\mu\text{R}/\text{hr}$  at 0 meters; Blackhawk/Bunney claims).

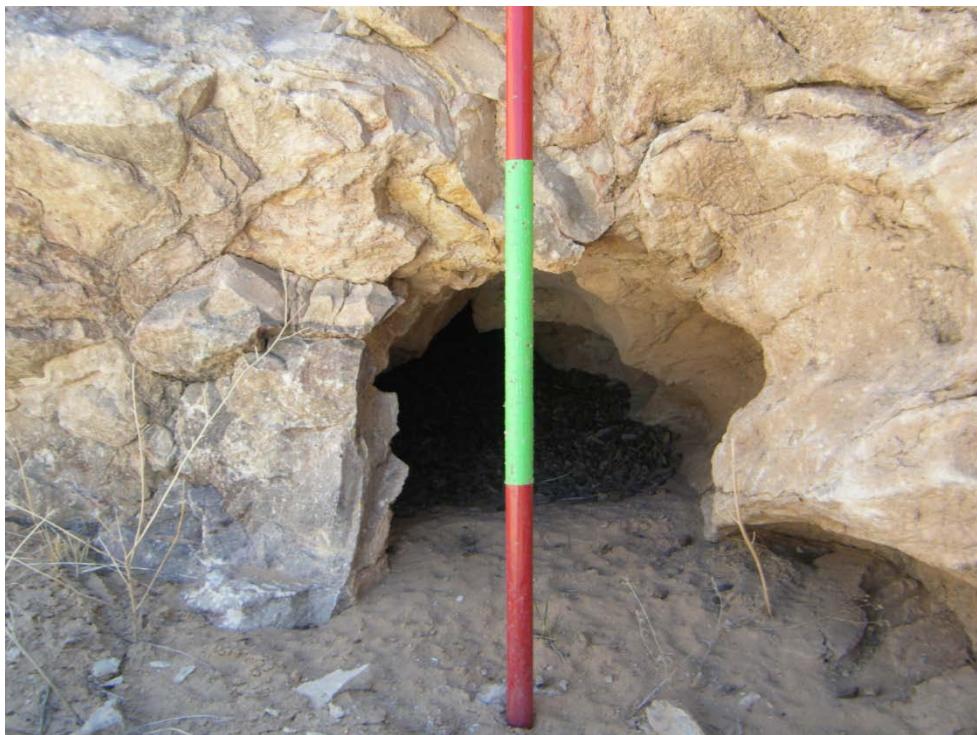
Photo 10-Looking east into Adit-2 (Blackhawk/Bunney claims).

Nine adits were found at the AUM Site. The first eight adits were found on the Blackhawk/Bunney claims, and the ninth adit was found on the Red Bluff No. 8 claim. Adit-1, Adit-2, and Adit-3 are small holes in the wall of Pit-2 (see Photos 9-11 in Appendix A). Adit-4 is accessed through a vertical entrance at the north end of Pit-2. Adit-5, Adit-6, Adit-7, and Adit-8 are located in the walls of Pit-3. Adit-5 has a timbered entrance and two passageways (see Photos 20 and 21 in Appendix A). Adit-6 parallels the axis of an anticline in the Todilto Formation (see Photos 22 and 23 in Appendix A). Adit-7 is partially infilled with sand (see Photo 26 in Appendix A). Adit-8 also parallels the axis of an anticline in the Todilto Formation (see Photos 30 and 31 in Appendix A). Adit-9 is located in the southwestern end of Pit-16 and is almost completely filled with mud (see Photo 77 in Appendix A). Although this adit appears to run underneath the fence between Section 4 and Section 9, there is no corresponding entrance in the pit immediately to the south on the Section 9 claims. The highest gamma ray readings at the entrance to these adits was 1000  $\mu\text{R}/\text{hr}$  at 0 ft above ground at radiation survey point Rad-11, associated with Adit-6.

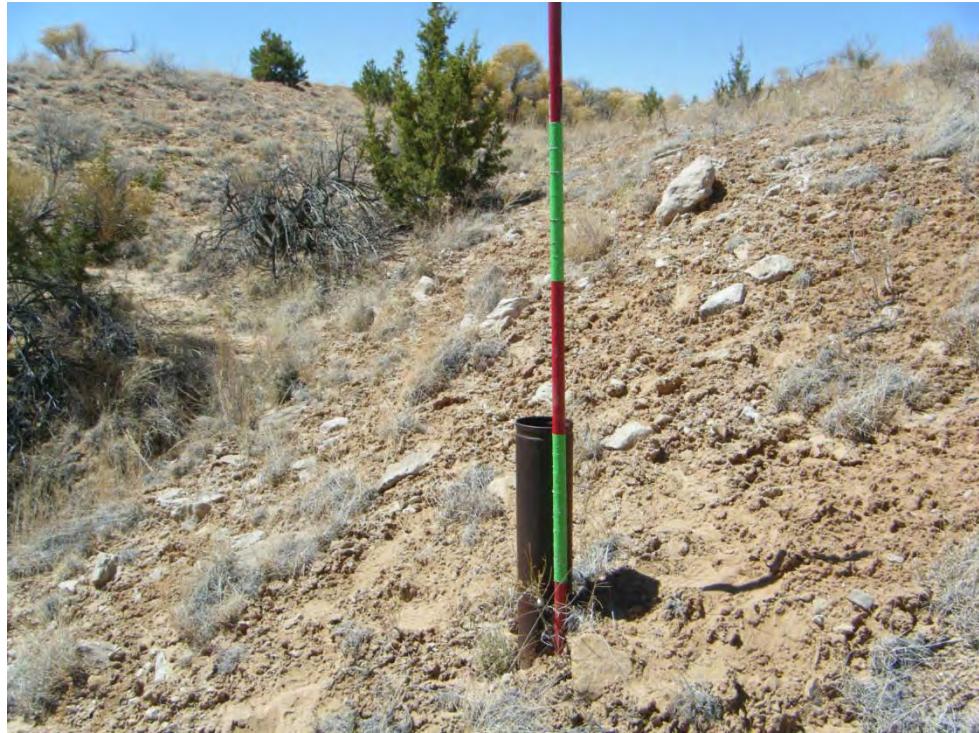
Photo 15-Looking south at a vent pipe (MiscPt-1; Blackhawk/Bunney claims).

Three barbed wire fences (Fenc-1, Fenc-2, and Fenc-3) were located on the AUM Site. A vent hole (MiscPt-1) was found on the Blackhawk/Bunney claims (see Photo 16 in Appendix A). This vent hole may have provided ventilation to the underground workings associated with nearby adits. A pile of wooden beams and metal (Equip-1) was found near Pit-3 on the Blackhawk/Bunney claims (see Photo 18 and 19 in Appendix A).

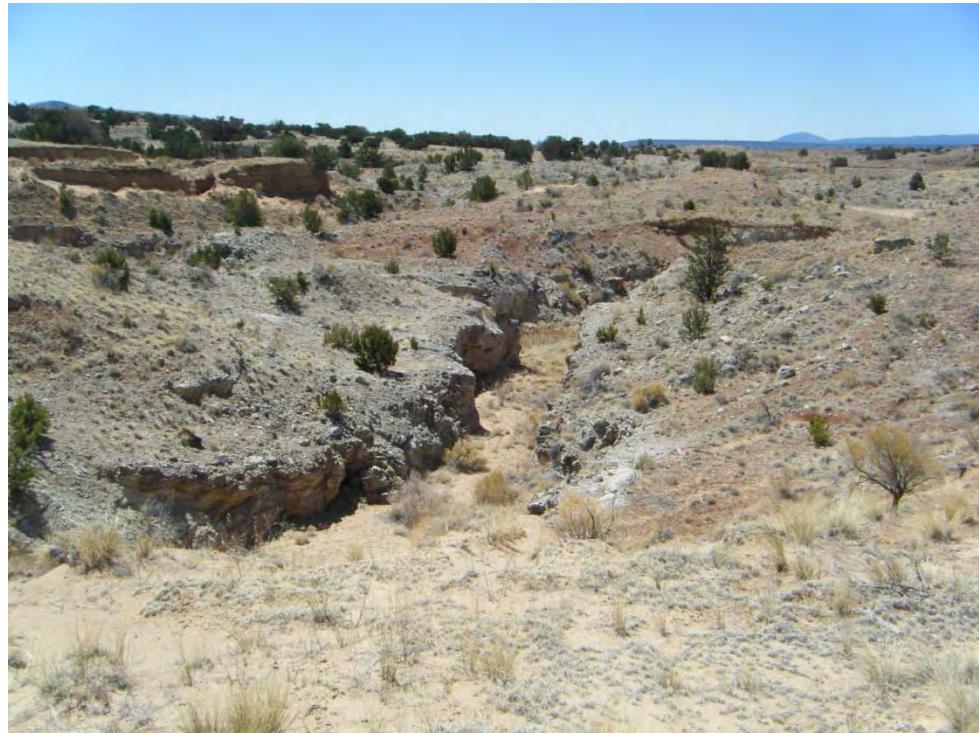
Photo 16-Looking north at the northern arm of Pit-3 (Blackhawk/Bunney claims).

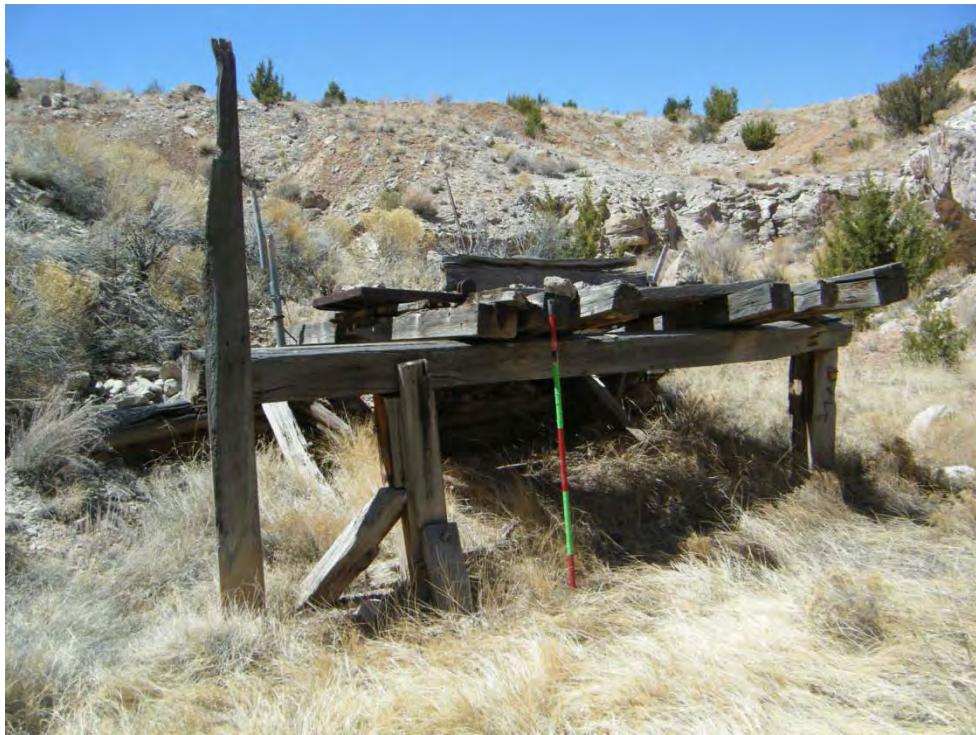
Photo 24-Looking west at old mine structure (StrucPly-1; Blackhawk/Bunney claims).

Two structures were found onsite. StrucPly-1 is a wooden structure located inside Pit-3 on the Blackhawk/Bunney claims (see Photos 24, 25, and 28 in Appendix A). StrucPly-2 is a wooden structure sunk into the ground on the Red Bluff No. 7 claim (see Photo 68 in Appendix A).

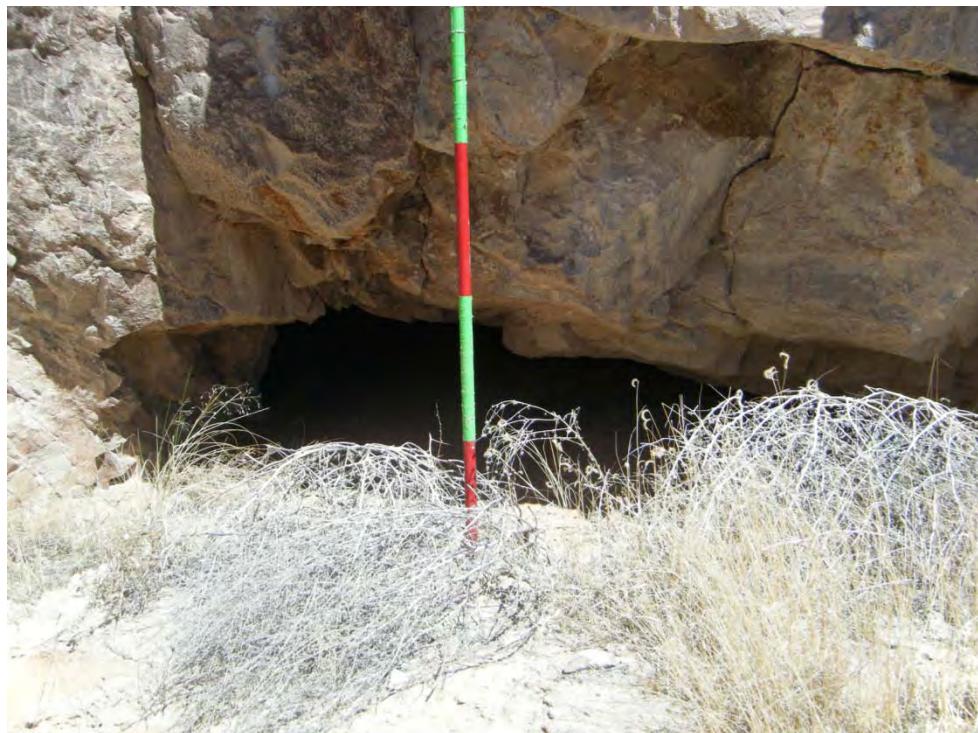
Photo 26-Looking east into Adit-7 (Blackhawk/Bunney claims). The adit appears half full of sand eroded from the walls of Pit-3.

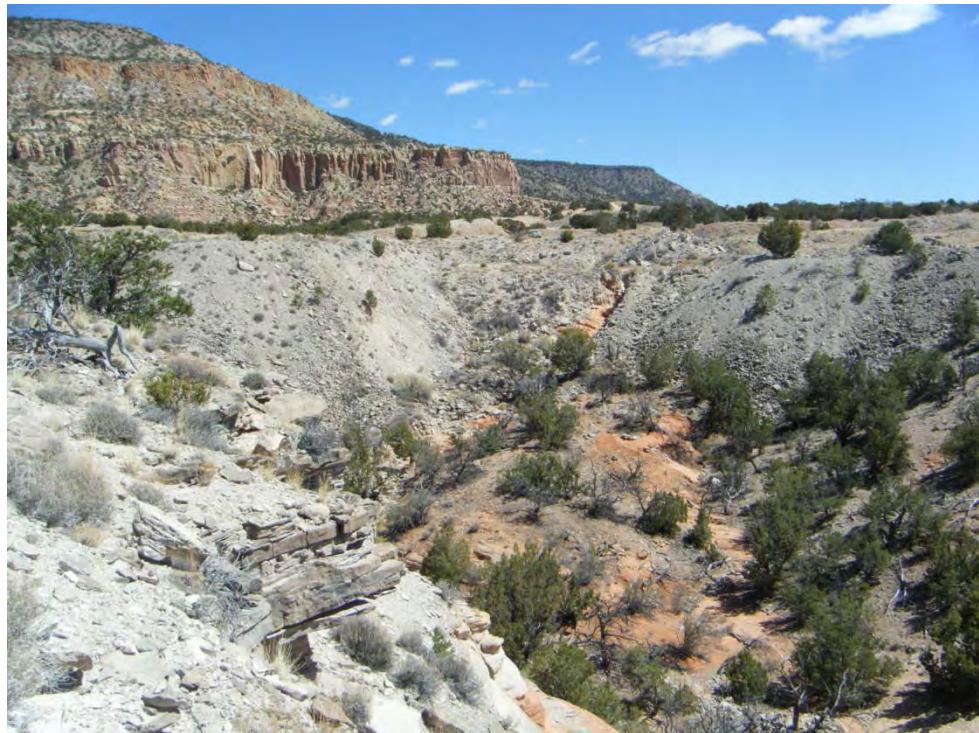
Photo 42-Looking east/southeast at the Gay Eagle claims. Note waste piles spilling down slope into drainage.

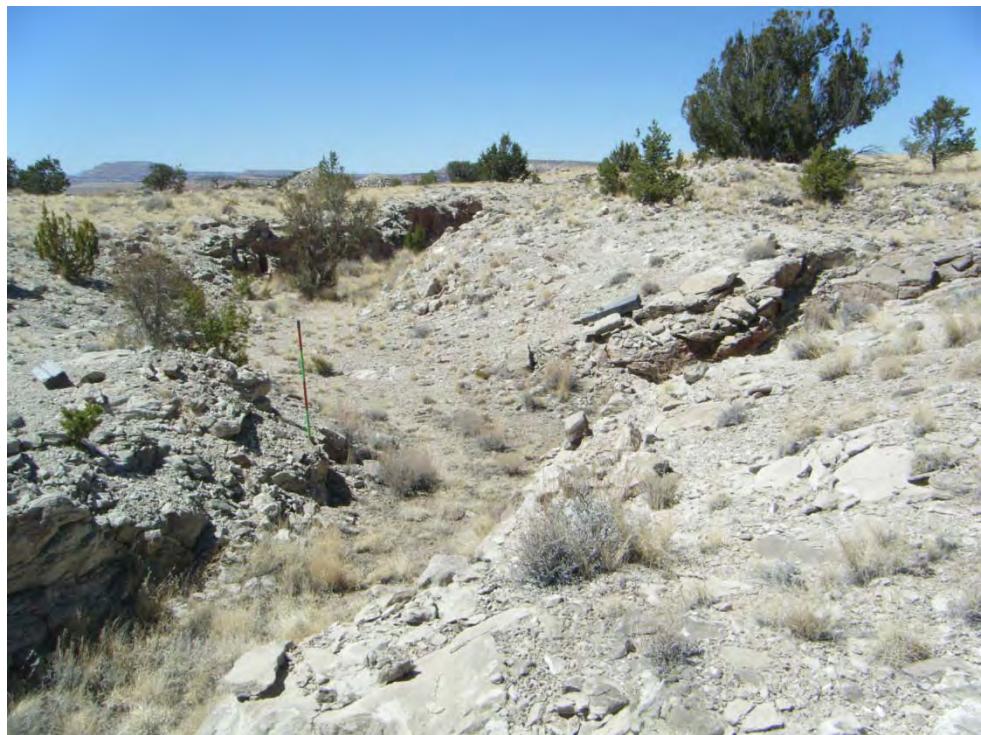
Photo 44-Looking northwest at Pit-5 (Blackhawk/Bunney claims).

point Rad-14 (see Photo 29 in Appendix A). The five western pits in the Blackhawk/Bunney claims of the AUM Site tend to be linear. No adits, structures, or other mine features were found within these pits. The highest gamma radiation measured in these pits was 2400  $\mu\text{R}/\text{hr}$  at 0 ft above ground at radiation survey point Rad-21 in Pit-5. Another reading of 1300  $\mu\text{R}/\text{hr}$  at 0 ft above ground was taken at radiation survey point Rad-17 in Pit-4. Pit-6, Pit-7, and Pit-8 had gamma radiation levels below 1000  $\mu\text{R}/\text{hr}$  at 0 ft above ground. See Photo 44 in Appendix A for an example of these pits.

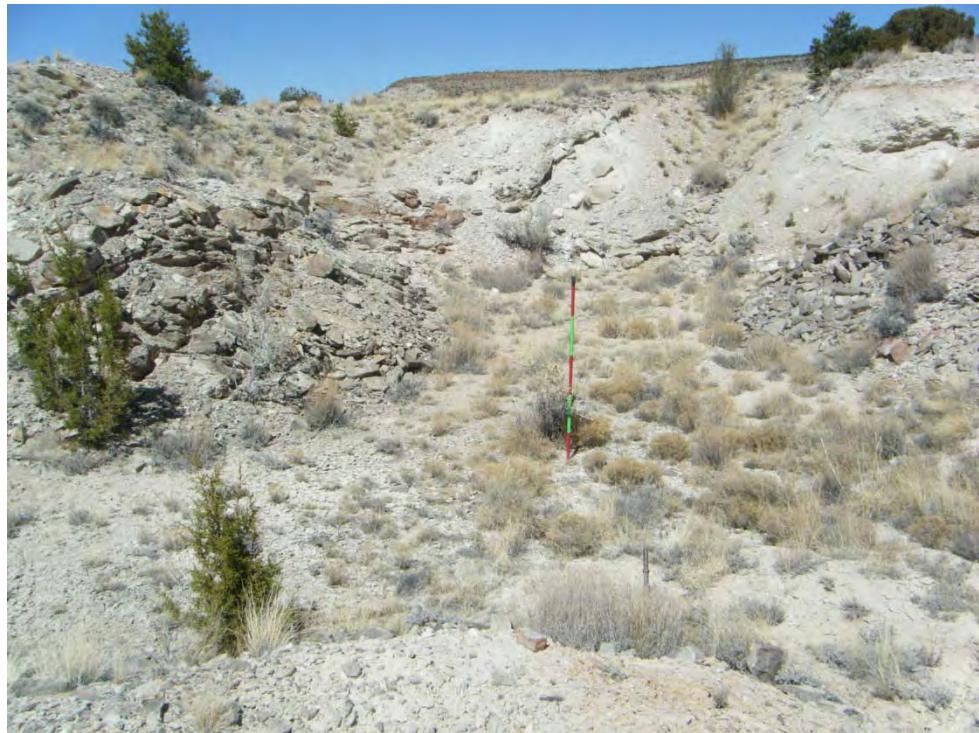
Photo 46-Looking northeast at CutPly-3 (Blackhawk/Bunney claims).

A total of three open cuts and twenty pits were found at the AUM Site. All three open cuts were located on the western portion of the Blackhawk/Bunney claims. They consist of shallow scrapings cut into the Todilto Formation limestones near the edge of the mesa. The maximum gamma ray reading in these cuts was 220  $\mu\text{R}/\text{hr}$  at 0 ft above ground measured at radiation survey point Rad-23 in CutPly-3. See Photo 46 in Appendix A for an example of these cuts.

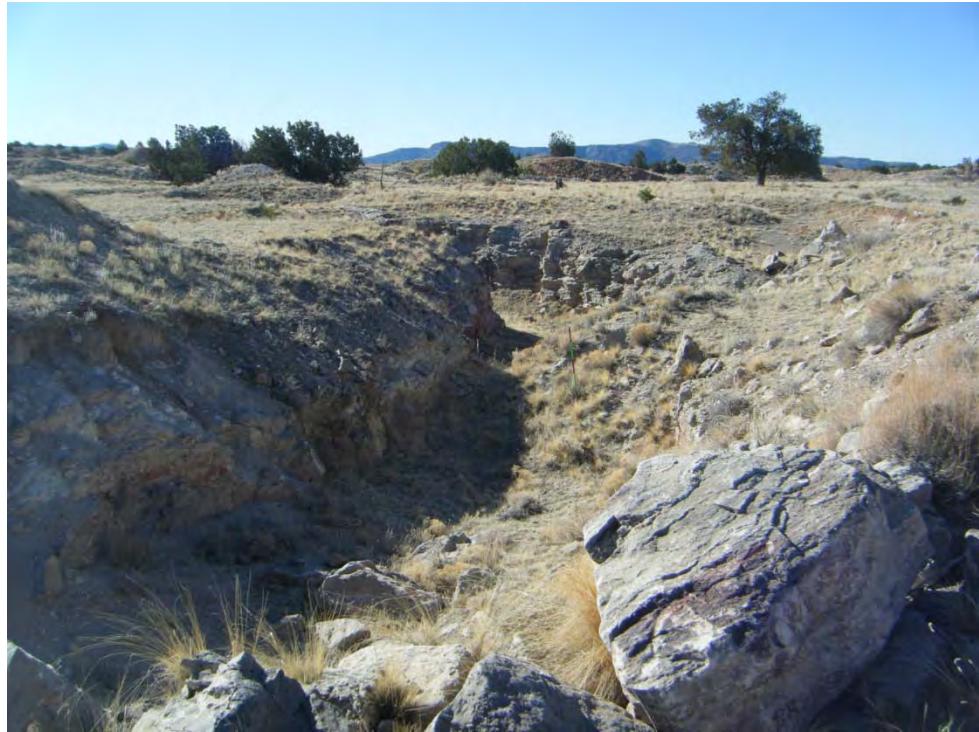
Photo 59-Looking south at Pit-10 (Red Bluff No. 7 claim).

The Red Bluff No. 7 claim contains four pits: Pit-9, Pit-10, Pit-11, and Pit-12. These pits are similar to the pits in the western section of Blackhawk/Bunney, but they are slightly larger. Out of the four, only Pit-10 has a gamma radiation count above 1000  $\mu\text{R}/\text{hr}$  at 0 ft above ground. See photo 59 in Appendix A for an example of these pits.

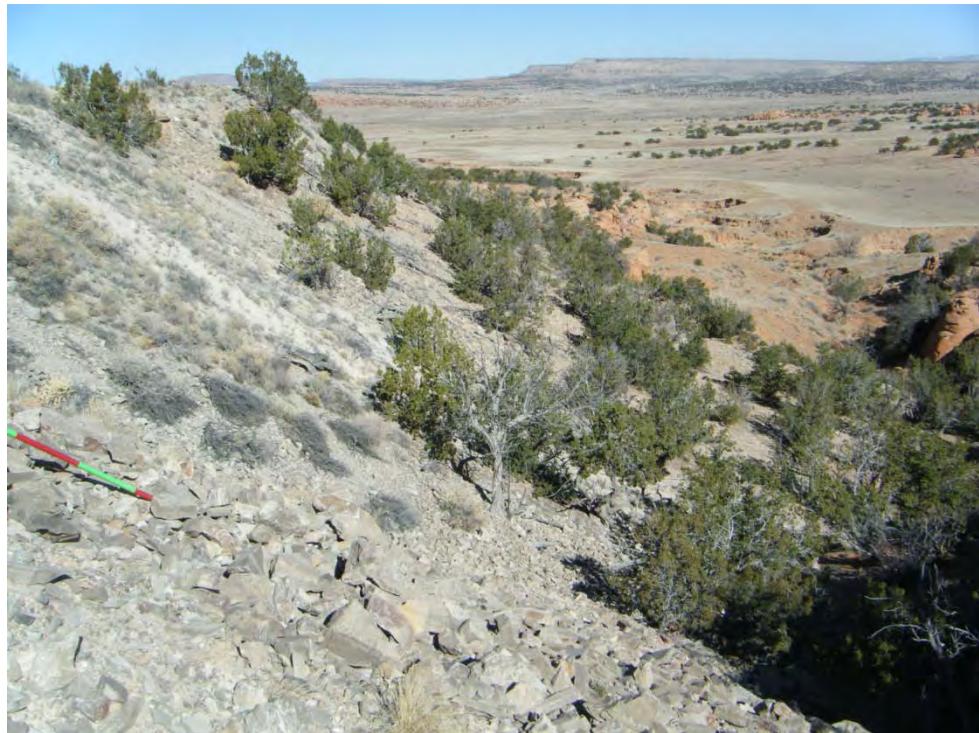
Photo 62-Looking northwest off the slope of the mesa. Debris from PilePly-9 spreads down the slope in the foreground.

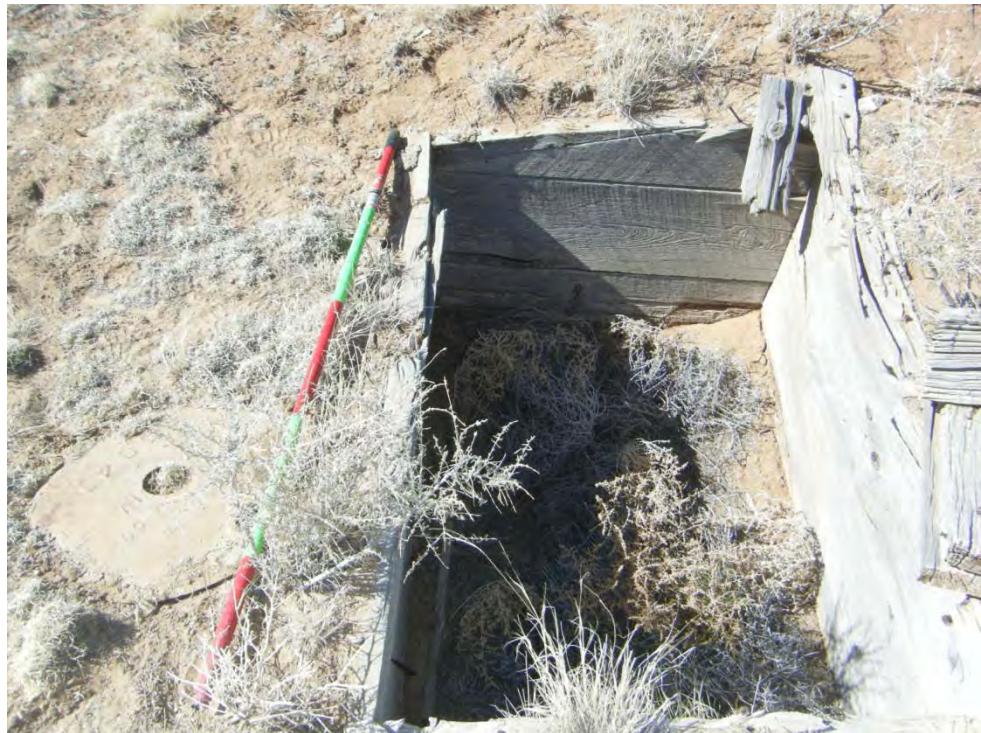
Photo 68-A wooden structure sunk into the ground (StrucPly-2; Red Bluff No. 7 claim).

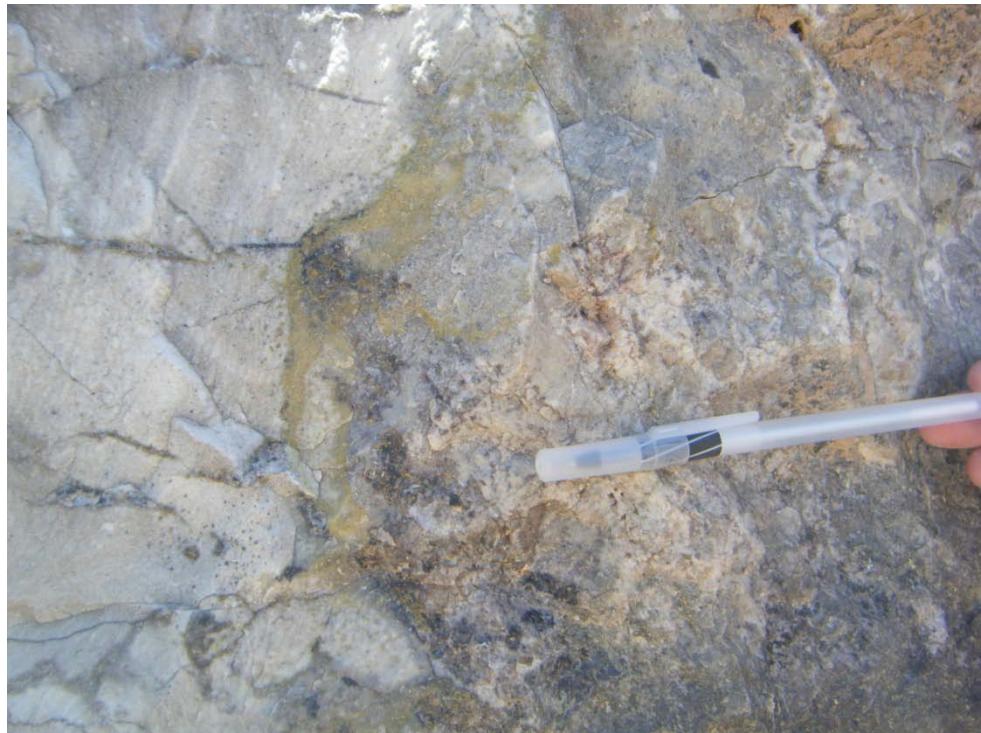
Photo 84-Radiation survey point Rad-50 in Pit-16 (over 5000  $\mu$ R/hour at 0 meters; Red Bluff No. 8 claim).

The maximum gamma radiation reading for the AUM Site was over 5000  $\mu\text{R}/\text{hr}$  at 0 ft above ground at radiation survey point Rad-50 (see Photo 7 and 8 in Appendix A) on the Red Bluff No. 8 claim. This reading was taken on mineralization on the walls of Pit-16 (see Photo 84). Other notable radiation readings were taken at radiation survey point Rad-33 (2000  $\mu\text{R}/\text{hr}$  at 0 ft above ground) in Pit-10 on the Red Bluff No. 7 claim and radiation survey point Rad-14 (2800  $\mu\text{R}/\text{hr}$  at 0 ft above ground) in Pit-3 on the Blackhawk/Bunney claims.

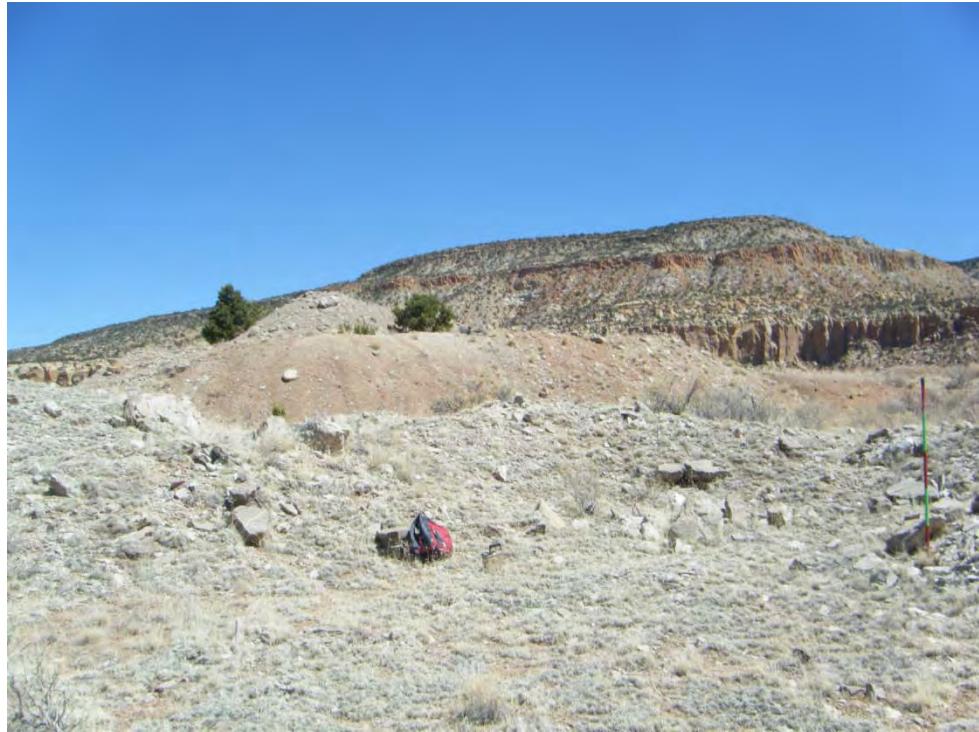
Photo 87-Looking east at PilePly-17 (Red Bluff No. 8 claim).

Piles on the AUM Site consisted of overburden, waste rock, or a combination of the two. Overburden piles tended to be larger, with shallower slopes (see Photos 33 and 87 in Appendix A for examples). These piles also tend to have less gamma radiation, though individual pieces of waste rock in the overburden can have elevated radiation levels. Waste rock piles tended to be smaller, steeper, and less well vegetated than overburden piles (see Photo 53 in Appendix A for an example). These piles also tended to have higher gamma radiation readings than overburden piles. Some waste rock piles spill over the mesa edge into drainages below (see Photo 62 in Appendix A for an example). The highest gamma radiation measurement on a pile recorded 1200  $\mu\text{R}/\text{hr}$  at 0 ft above ground at radiation survey point Rad-47 on PilePly-16.

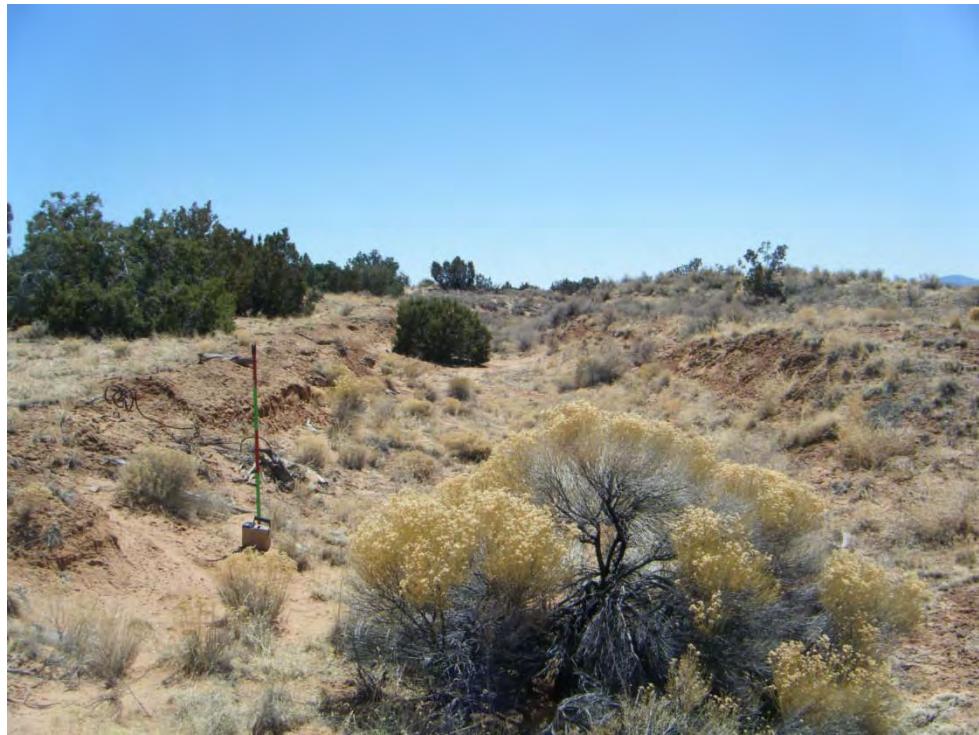
Photo 90-Looking south at Pit-17 (Red Bluff No. 10 claim).

The four pits located in the Red Bluff No. 10 claim had radiation levels similar to or lower than background. These pits are linear scrapings in the aeolian overburden, and no Todilto Formation is exposed. See Photo 90 for an example of these pits.
